Full Length Research Paper

The Financial Implications of Environmental Degradation: A Case Study on Floods and Erosion in Benin City, Nigeria

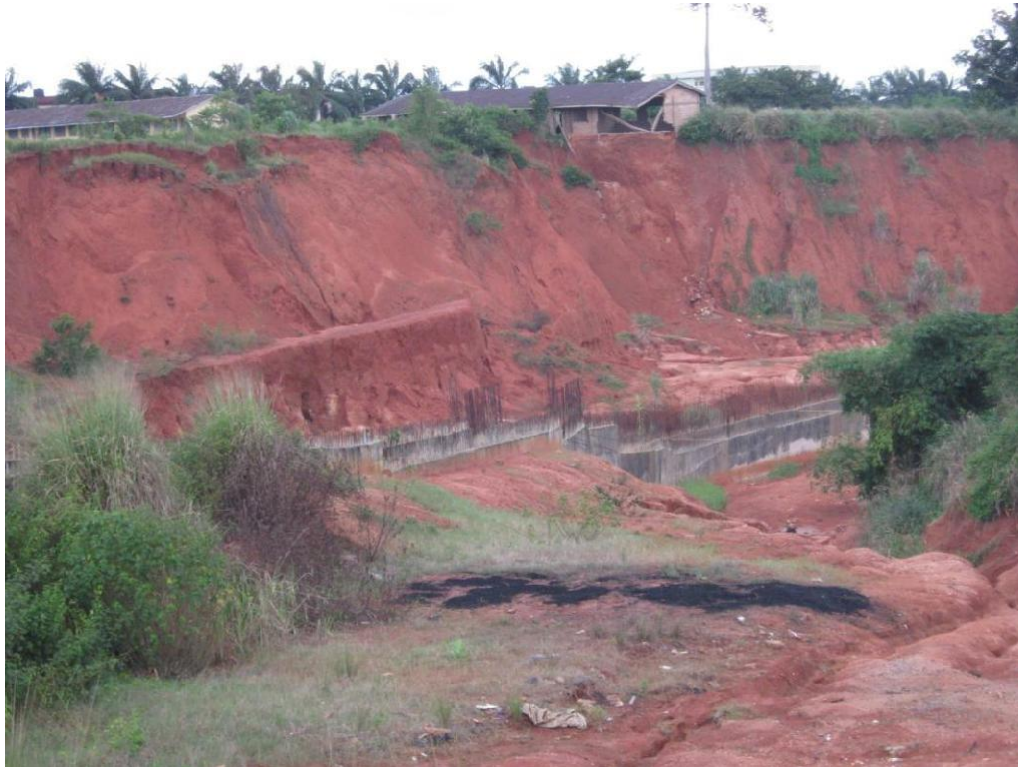
The number of buildings that caved into the gullies and those abandoned due to the threat of the gullies and sand deposits were 58 and they were estimated to cost ₦650.5 m (\$4.33 m) (Table 2). Out of these 58 building, the Ogbesan Quarters gully erosion has engulfed two blocks of 16 classrooms of Queen Ede Primary School and the third classroom building has been abandoned

since part of it has caved into the gully (Plate 1). The Ogbesan quarters gully has cut two roads into two and the head-on erosion is just 30.4m away from the Benin-Agbor Express Road. If no urgent and serious action is taken now, judging from the rate of head-on erosion (Table 1), the gully will cut the road into two in the next six years. The most worrisome is the University of Benin gully that has claimed one-fourth of the western fence of the University, staff quarters and buildings of individuals of Ekosodin community sharing common boundary with the University. The largest Block of Flats of the University that house both staff and students and other staff quarters are under serious threat. Gully erosion in Benin City has caused a lot of hazard not only to individual property but also to government infrastructure. The total area eroded by the gullies together with the sand deposits measured 560,582 m². This area was converted to building plots of 30 by 30 m (the standard building plot of land in the study area) to ease estimation. The total building plots were 623 and these amounted to ₦1.52 billion (\$10.2 m) (Table 2). Magbemi (2008) and Okechukwu (2010) also mention that buildings worth millions of Naira have been destroyed by gullies in Nigeria, but these works did not carry out detailed study of the number of buildings affected and the cost of gully damage to property in their study areas.

Plate 1. Ogbesan Gully, Benin City showing school building caving in and the failed community effort of drain construction to solve the gully problem.

The survey also shows that lack of drainage system (92%), poor maintenance of the existing drains (84%), negligence on the part of government (82%) and improper land use (76%) were identified as the major causes of erosion in Benin City. Since the drainages are inadequate to properly channel the water, the water then finds it way thereby creating its channels which may later develop to gullies. The neglect by government in solving the erosion problems when the gullies were small led to the present precarious state of gullies in Benin City. The communities where the gullies are found have been making frantic efforts in resolving the erosion problems in Benin City. For example, the Ogbesan Community raised money in 2007 to channel the water to the river. The drain constructed (Plate 2) could not survive the first rainy season before the lateral erosion led to its collapse. This clearly shows that the problem is beyond their financial and technical reach to solve. The solution to most gullies" problems in Benin City seems hopeless since the cost of resolving the problem is now beyond the financial capability of the inhabitants, institutions and even the State Government. The Edo State Government made it clear since 2003 that the solution to gullies that this study is investigating is beyond her financial reach. To make the situation more hopeless, the Minister of Environment having inspected the gullies in Benin City and other parts of Edo State in 2010 openly declared that the assistance of the World Bank is needed to tackle the erosion menace in the State. This paper is therefore making a clarion call on the World Bank and other international ecological foundations to come and rescue the inhabitants of Benin City from the hazards of gullies.

The paper shows that while flooding problem in Benin City is still within the reach of the state government to solve, the gully problem has gone beyond the financial limits of the state government. The Federal Government in collaboration with international organizations should as a matter of urgency come to the rescue of those being threatened by gullies in Benin City. The Edo State Government should as a matter of urgency start solving the smaller gully erosion problems in Benin City now before they turn to major gullies that will demand billions of naira to solve. A stitch in time, they say saves nine.

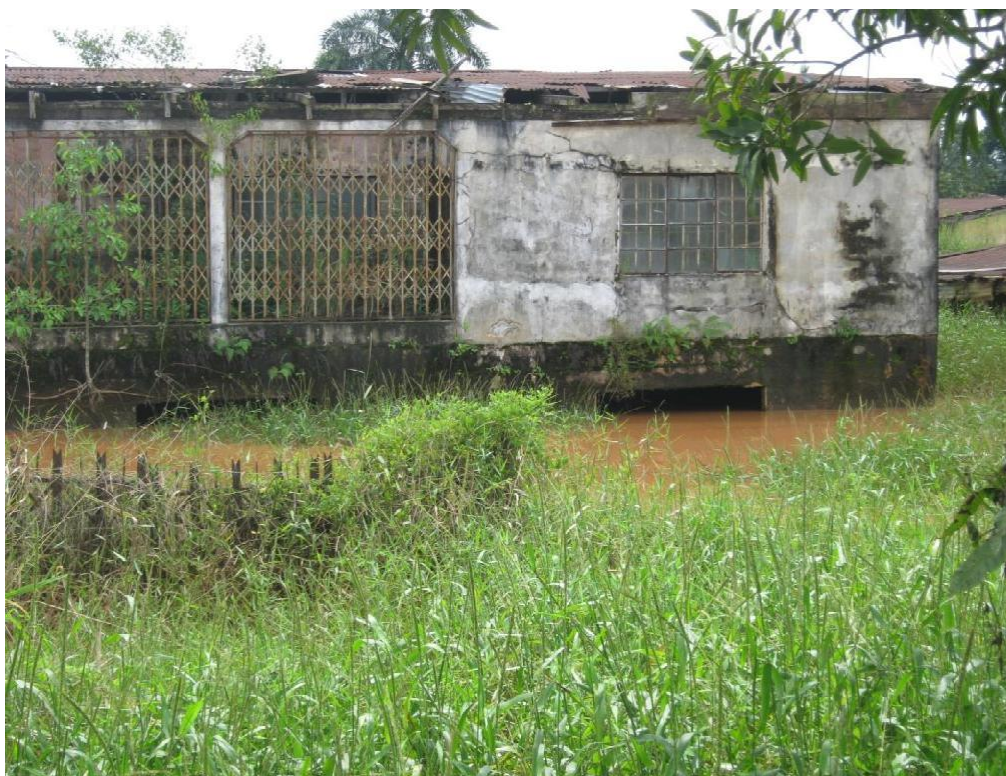
The flooded areas covered 913,313 m² and the number of buildings abandoned as a result of the flood (Plate 2) was 67 and these cost ₦1.05 billion (\$7.02 m) (Table 3). The flood in Dumez Road and Siloko/Uwelu Roads has totally covered the two primary school buildings and the

Plate 2. One of the flooded and abandoned buildings along Siloko Road by Teachers' House.

two schools have been abandoned and their students and staff relocated. The flood creates poundage which usually last for hours, weeks or months. So the flooding pattern experienced in Benin City is both flash and seasonal. In the areas affected by prolonged poundage (months) most of the building plots were left undeveloped. These were measured and they totaled 102 plots of land, which cost N550.6 m (\$3.4 m) (Table 3). The total financial cost of flooding (Number of building and building plots abandoned) therefore amounted to N1.6 billion (\$10.6 m).

The government should ensure that buildings and other structures on the natural waterways are pulled down to allow free natural flow. Pulled down structures with approved government plans should be adequately compensated. The Urban and Town Planning Department together with the Ministry of Environment should encourage urban forestry and discourage the practice of totally cementing the entire section of the compound not built. Trees, grasses and flowers will not

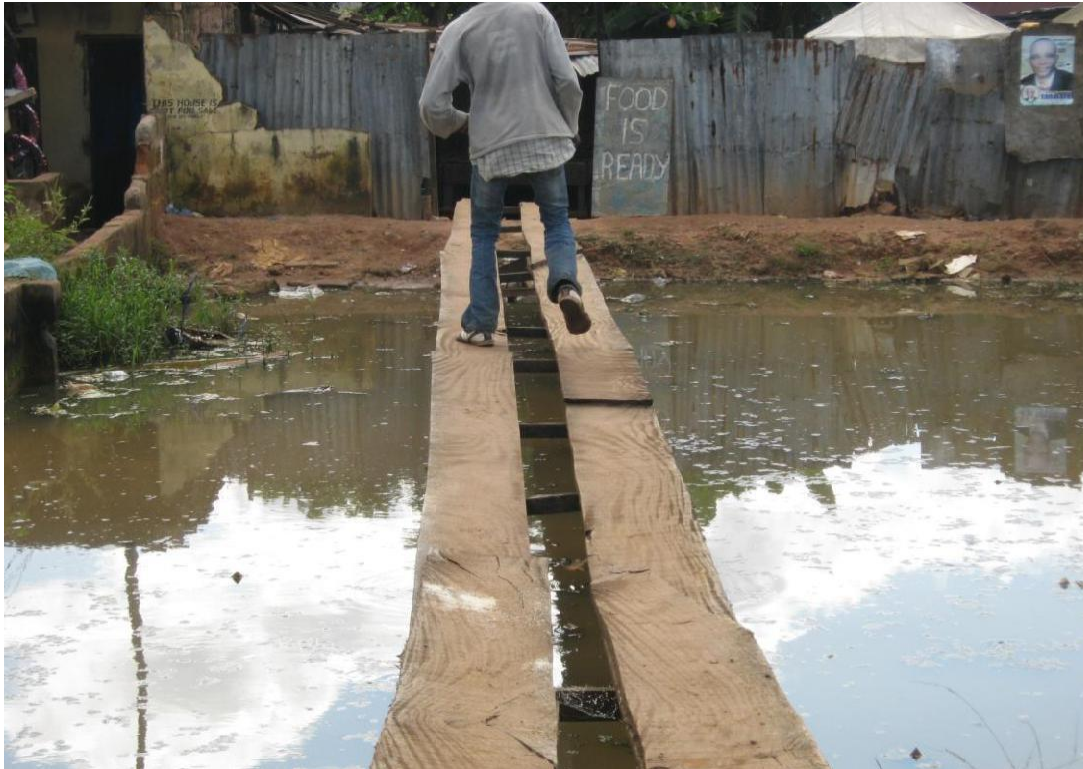
Plate 3. Flood problem: Local effort of bridge construction to get to homes, business centres and eateries.
