Full Length Research Paper

Evaluation of the existing conservation practices on Lake Haramaya Catchment

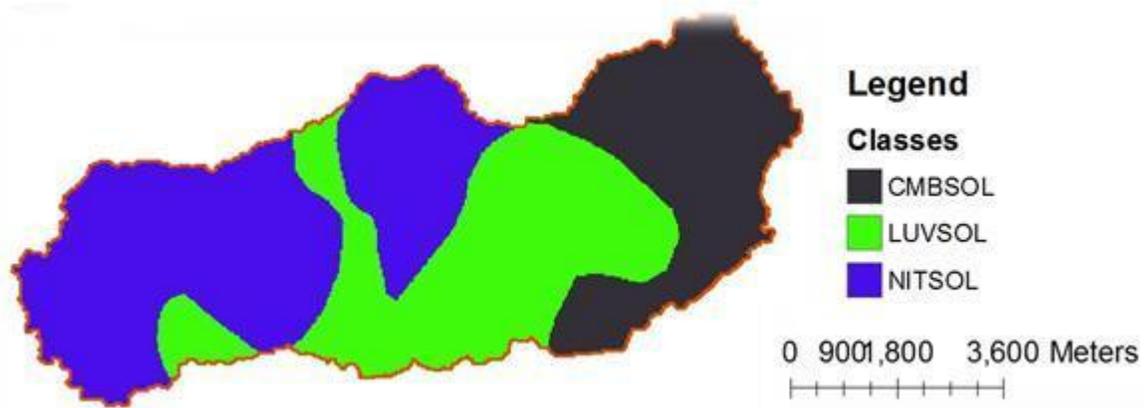
Figure 5. Soil map of Lake Haramaya catchment based on classification system of the Food and Agriculture Organization (FAO).

The soil types of the watershed gathered from the Ethiopian soil map are classified as Luvisols (LUVSOL), Nitisols (NITSOL) and Cambisol (CMBSOL) as shown in Figure. Nitisols which covers greater than 43% of the watershed soil is the most dominant soils group.

The remaining soil groups Luvisols and Cambisols cover 32 and 25% of the study area respectively. Temporal and spatial rainfall (precipitation) characteristics are very important factors that affect runoff generation from catch-
