# Corrosive properties of different surfaces to understand the degradation mechanism of paint film

Inadequate surface preparation of mild steel panels prior to painting could be the leading cause of the paint film failure. This work evaluated the surface preparation treatments in order to improve the paint integrity and thereby increasing the corrosion resistance of the steel panel in artificial sea water. The AISI 1020 steel ground and grit blasted samples were prepared followed by applying zinc based epoxy primer and top coat. The degradation mechanism was devised by immersing the samples in 3.5% NaCl solution. The degradation due to blistering within the paint was analyzed by following ASTM D-610 and ASTM D-714. Energy Dispersive Spectroscopy of corrosion product revealed a correlation with the degradation mode of painted sample. It was deduced that degradation of paint depends on surface morphology of substrate.

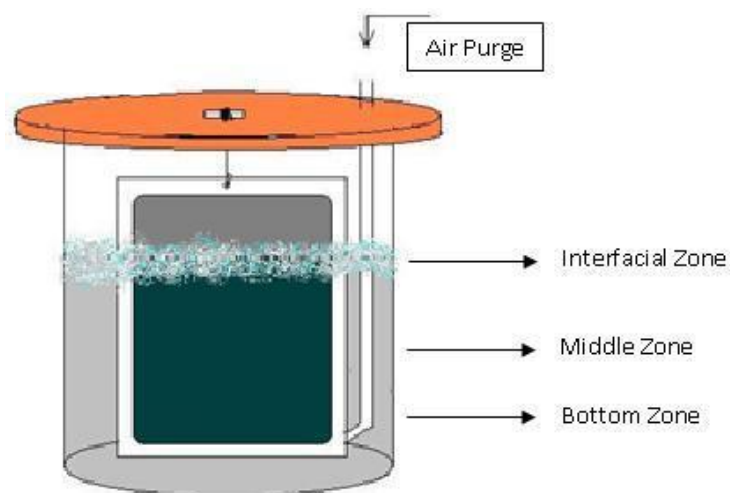
Figure 1. Panel immersed in aerated 3.5% NaCl.

The cured painted panels were then immersed in artificial aerated sea water (3.5% NaCl solution prepared in de-mineralized water) to analyze the painted surfaces performance under accelerated conditions. The 2/3 portion was immersed in solution while 1/3 portion was out of solution in order to simulate the paint film behavior in the bottom, middle and interfacial. The severity of electrolyte towards paint deterioration was measured in all these zones by visual and microscopic examination. The experimental cell is shown in Figure 1.

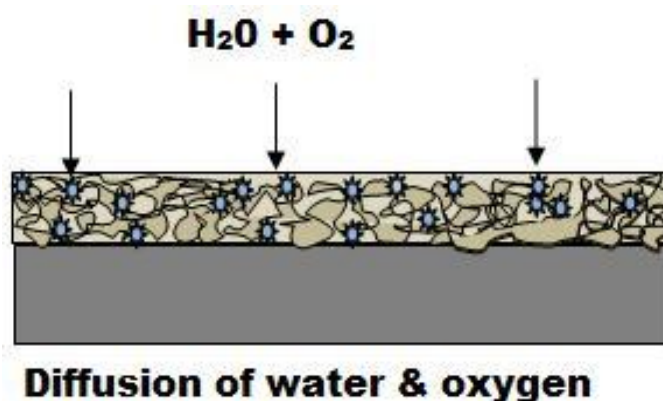
Figure 2. Take up of aerated water by the paint film within incubation period.

The incubation period is always required for the initiation of a blister on polymer-coated steel panels. For panels containing no apparent defects or small pores, the time taken by the blisters to nucleate is much longer than for panels containing defects [Robert et al., 1997; Chuang et al., 1999]. The water uptake by the polymer film is a function of degree of crosslinking and film thickness. In saline solutions the diffusion of ionic species through the film also depend on chain structure and length of diffusion path. High degree of crosslinking limit the approach of water and ions to the steel surface due to tortuous path

within the polymer film as depicted in Figure 2. The paint condition before immersion was as presented in Figure 3a. The absorption of water within the intrinsically defective paint film chain structure will cause a concentration gradient in the film for more water take up hence causing swelling as shown in Figure 3b. The initial 72 h delay in blister formation, when G02 painted surface was immersed in a water solution containing salt, the diffusion was gradual leading to film swelling with a volume expansion. The corrosion spots were appeared at surface of paint film which estimated according to ASTM D610 were close to rust grade 8-S (0.1% Rusted).

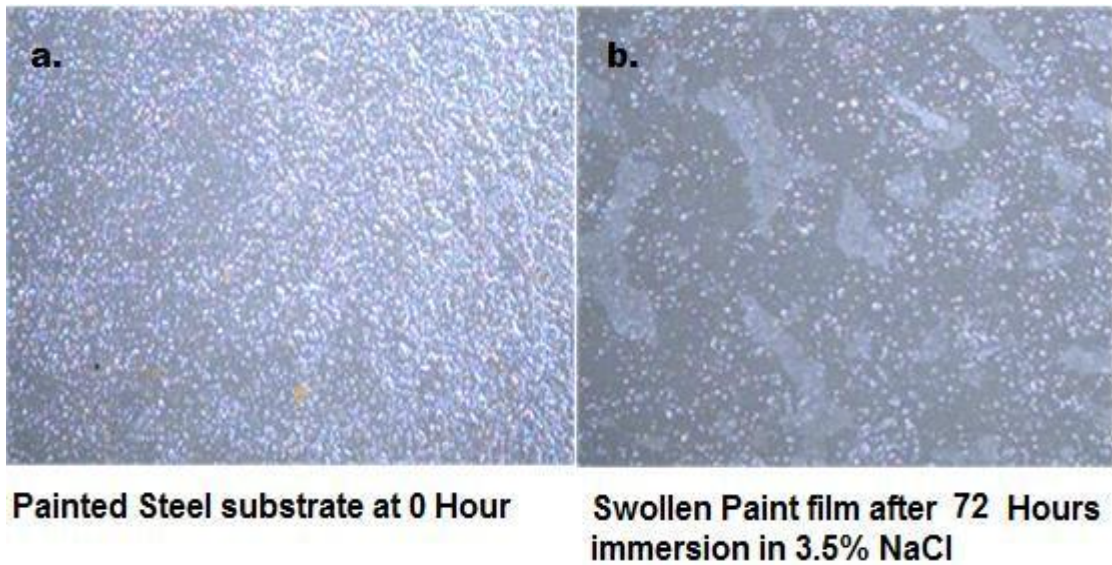
Figure 3. G02 paint film surface condition at (a) 0 hour (b) 72 h.

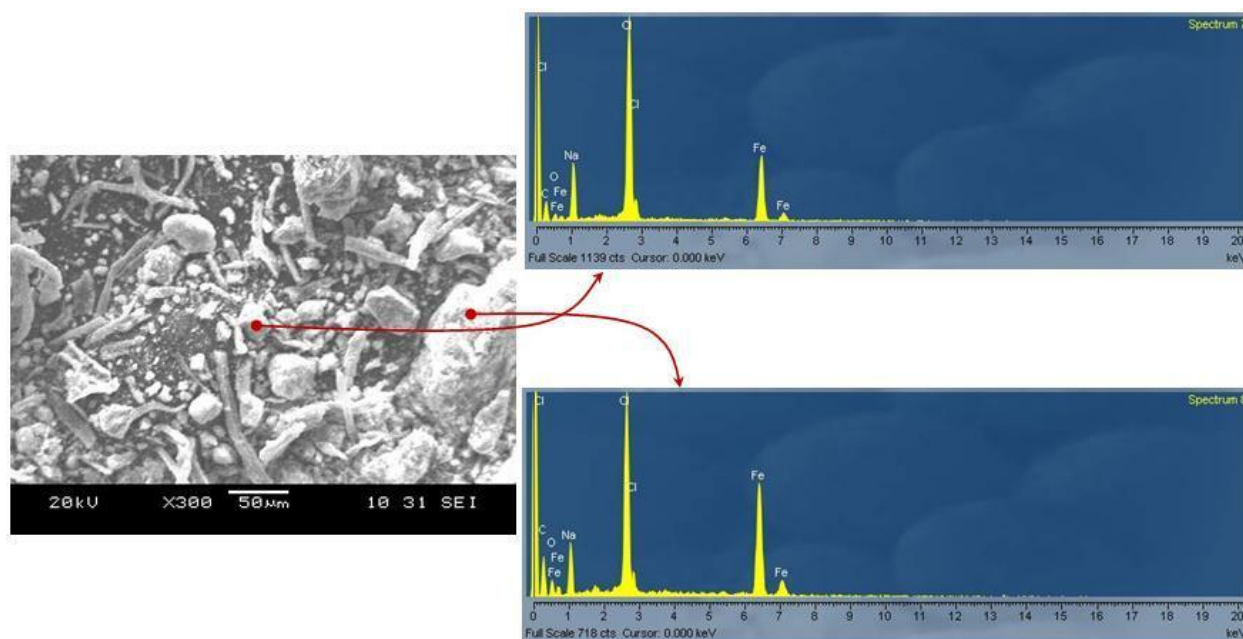
**Figure 4.** SEM, Energy dispersive spectroscopy elemental analysis.

The formation of NaOH locally at the Blister initiation site increased the pH blister solution to 8. The Energy Despersive Spectroscopy (EDS) elemental analysis at the rust spot qualitatively validated the presence of  $Na^+$  and  $Cl^-$  ions in the spectrum as shown in Figure 4. The high intensity peaks of  $Cl^-$  in EDS spectrum represented the domination of  $Cl^-$  ions ingress at the paint/metal

interface than  $\text{Na}^+$  ions.

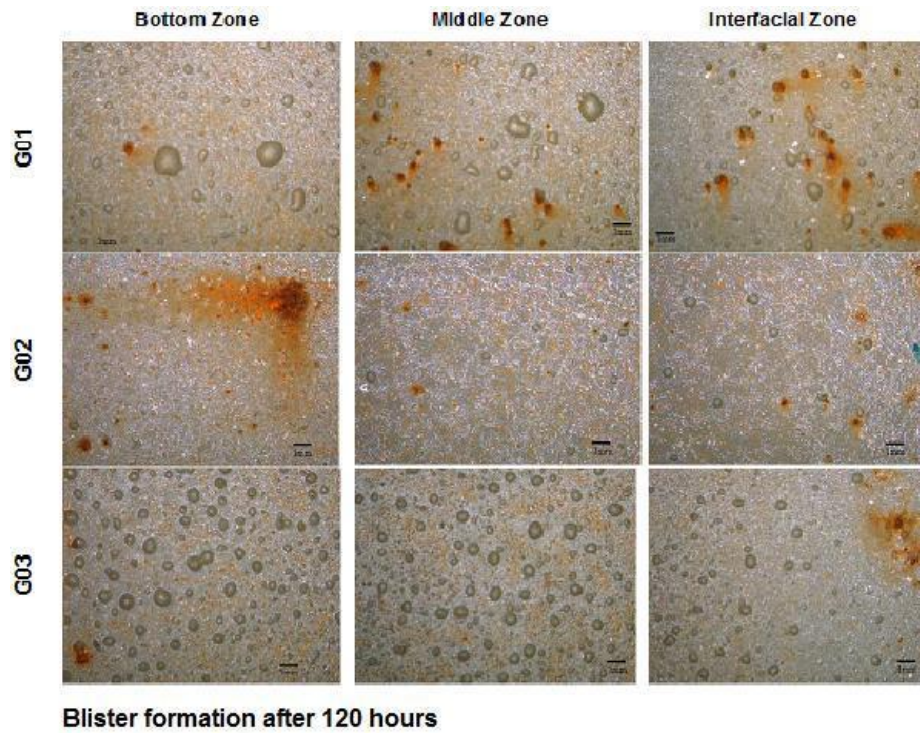
Figure 5. Stereo-micrographs of blister formation after 120 h immersion.

The pictorial view of blister growth when painted steel panels were exposed to artificial sea water is shown in Figure 5 to 7 for 120, 240 and 480 h respectively.

The pictorial data of samples G01, G02 and G03 is provided in Tables 3 to 5 respectively for the evaluation of blister size, frequency and rust grades by following ASTM D-714 and ASTM D-610 respectively. It was evaluated from data that the blister growth rate was higher for G01 and G03 due to comparitively least surface area available for uniform adhesion to the steel surface than the rougher surface of G02. It was therfore very few blister having size 10 and rust grade 6 evan after 120 h at the bottom zone of panel. The detail of paint surface blister and rusting grades at the bottom, middle and interfacial zones of panel may be pridicted from these tables.

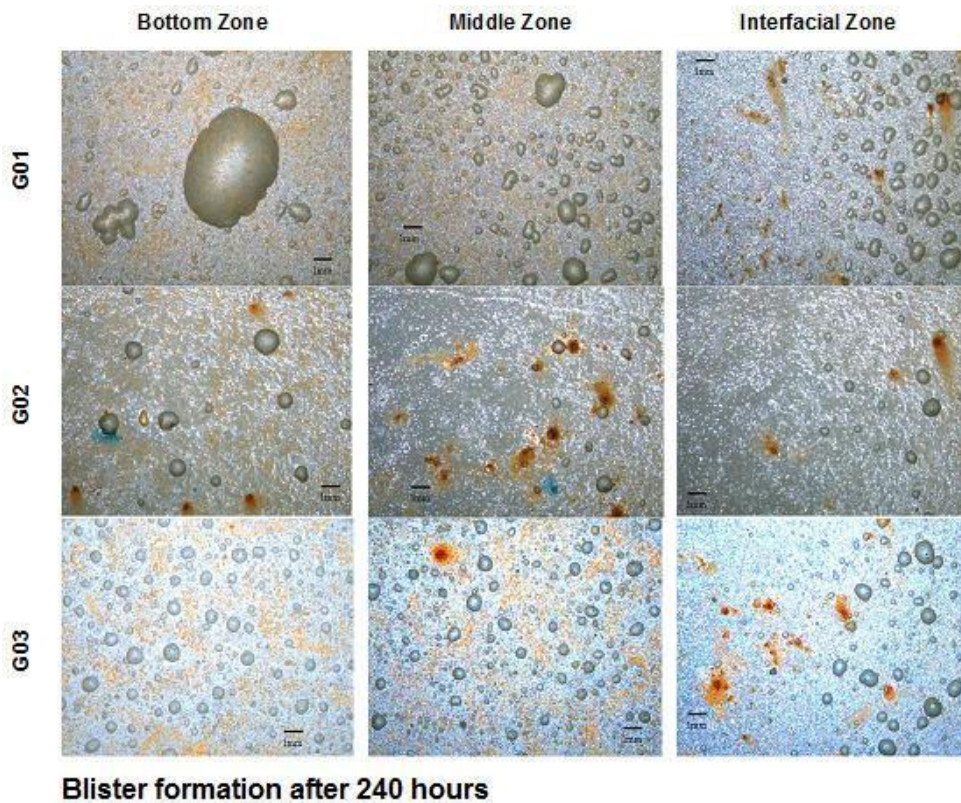
Figure 6. Stereo-Micrographs of painted surfaces after 240 h.

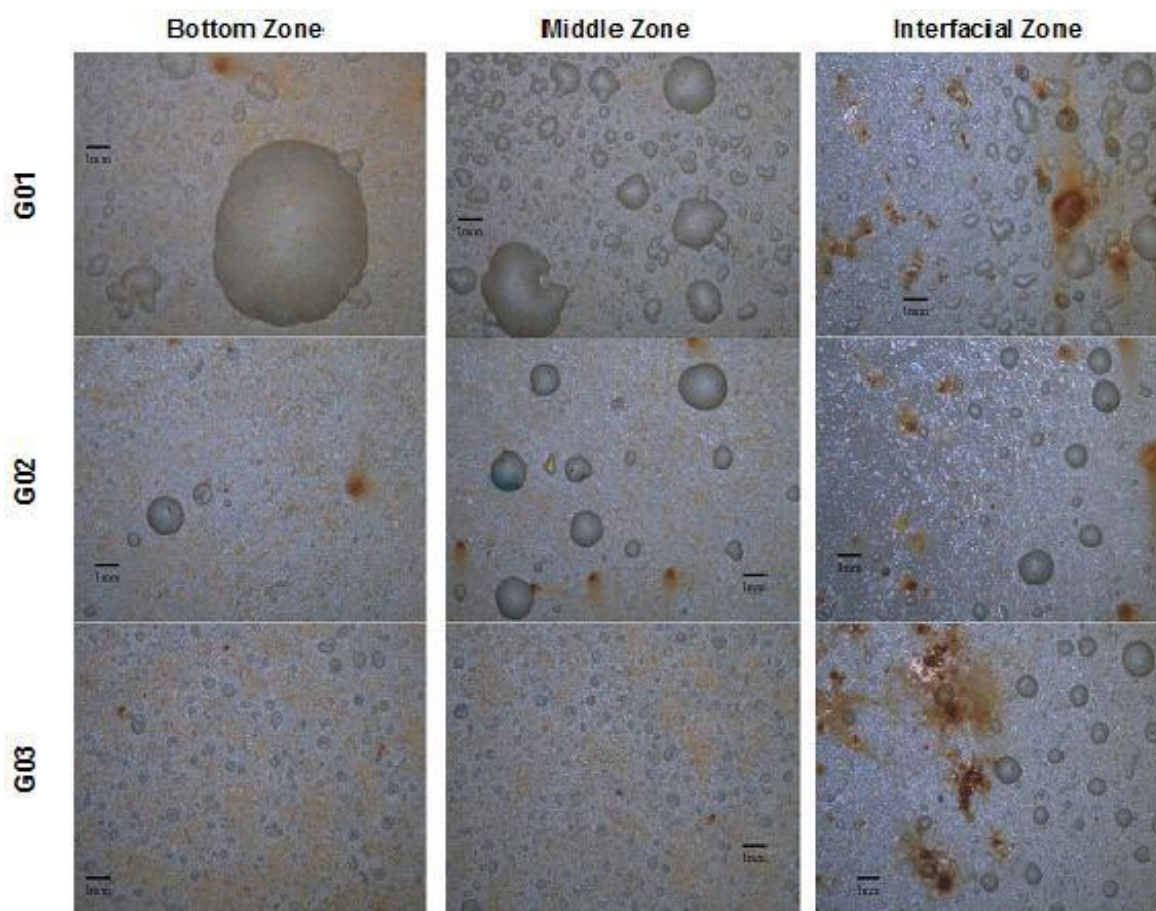
**Growth of blisters after 480 hours**

**Figure 7.** Stereo-micrographs of painted samples after 480 h.
